EMERGENCY AIRWORTHINESS DIRECTIVE

AD #: 2003-08-53

Send to all U.S. owners and operators of Eurocopter France Model SA-365N1, AS365-N2, AS 365 N3, and SA-366G1 helicopters.

2003-08-53 EUROCOPTER FRANCE: Docket No. 2003-SW-20-AD. Supersedes AD 2000-10-08, Amendment 39-11732, and 2000-10-08R1, Amendment 39-12452, both Docket No. 99-SW-34-AD.

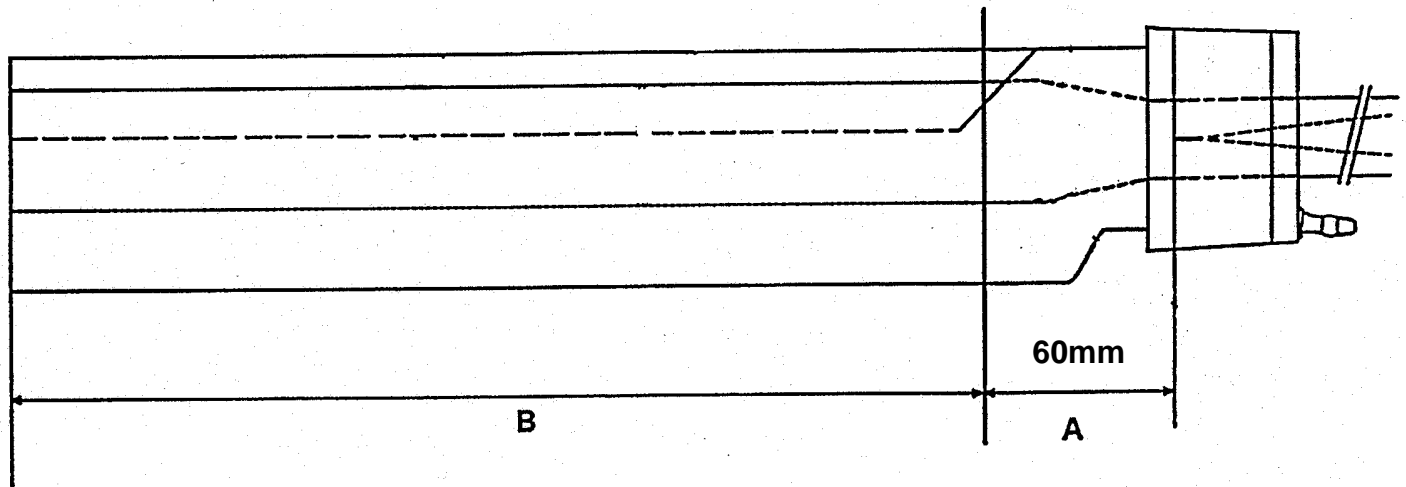
(a) Within 10 hours time-in-service (TIS) and thereafter before the first flight of each day, visually check each blade for a crack, blister, or wrinkling. An owner/operator (pilot), holding at least a private pilot certificate, may perform the visual check and must enter compliance into the aircraft maintenance records in accordance with 14 CFR sections 43.11 and 91.417(a)(2)(v)). See Figure 1 as follows:

(1) Zone A: If a blister is detected on the blade suction face, conduct a tapping test inspection on the whole blade for bonding separation.

(2) Zone B: If a crack, wrinkling, or a blister is found, replace the blade with an airworthy blade before further flight.

(2) Thereafter, at intervals not to exceed 25 hours TIS, conduct a tapping test inspection for bonding separation on blades, P/N 365A12-0020-02 or 365A12-0020-03, in Zone A as depicted in Figure 1 of this AD.

(3) Thereafter, at intervals not to exceed 100 hours TIS or 200 cycles, whichever occurs first, conduct a tapping test inspection for bonding separation on blades, P/N 365A12-0020-02 or 365A12-0020-03, in Zone B as depicted in Figure 1 of this AD. If a crack, wrinkling, or a blister is found, replace the blade with an airworthy blade before further flight.

(i) For blades, P/N 365A33-2131-all dash numbers, 365A12-0010-all dash numbers, and 365A12-0020-00, and -01, if bonding separation or a crack is found, replace the blade with an airworthy blade before further flight.

(ii) For blades, P/N 365A12-0020-02, and -03, if bonding separation exceeds 900 mm² in a 30 x 30 mm square or if there is a crack, replace the blade with an airworthy blade before further flight.

(i) If bonding separation exceeds the criteria specified in paragraph (b)(1)(ii) of this AD or if a crack is found, replace the blade with an airworthy blade before further flight.

(ii) If bonding separation is present and within tolerance of the criteria specified in paragraph (b)(1)(ii) of this AD, conduct a tapping test before the first flight of the day and as often as necessary during the day ensuring that the TIS between tapping tests does not exceed 10 hours TIS between tapping tests.

(iii) Within 25 hours TIS after the discovery of skin debonding in Zone A, remove and replace the blade with an airworthy blade.
